**MONITORING AND INVESTIGATION OF A MULTI-SUITE
RESIDENTIAL COMPLEX IN WHITEHORSE, YUKON,
FROM 1988 To 1992**

**Efficiency and Alternative Energy Technology Branch, CANMET
Energy, Mines and Resources Canada
Ottawa, Ontario
March 15, 1993**

**Howell-Mayhew Engineering Inc.
15006-103 Avenue
Edmonton, Alberta
T5P 0N8
(403) 484-0476**

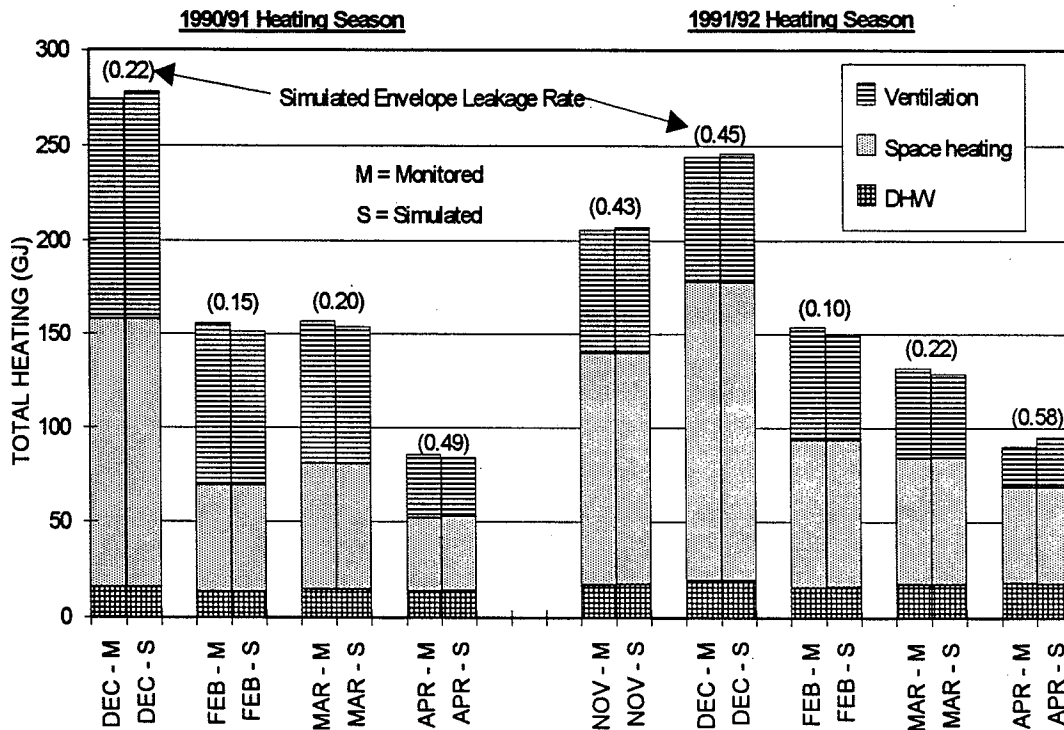
Figure 9: DOE Simulated Envelope Leakage Rates

The DOE simulation work indicated that, with the advanced R-2000 envelope air barrier system, the building had the capability of achieving an uncontrolled leakage rate of 0.1 ACH². The rate that was typically achieved at Closeleigh Manor, however, appeared to vary significantly from 0.1 ACH and, at times, there was as much outside air leaking across the envelope as there was being supplied by the central ventilation system. From Figure 10, it can be seen that the variations caused notable increases in space heating requirements. For example, November and February 1992 had HDD of 816 and 860 respectively. The space heating required in November, however, with a simulated envelope leakage rate of 0.43 ACH, was 122.5 GJ compared to 77.7 GJ, an increase of 58%.

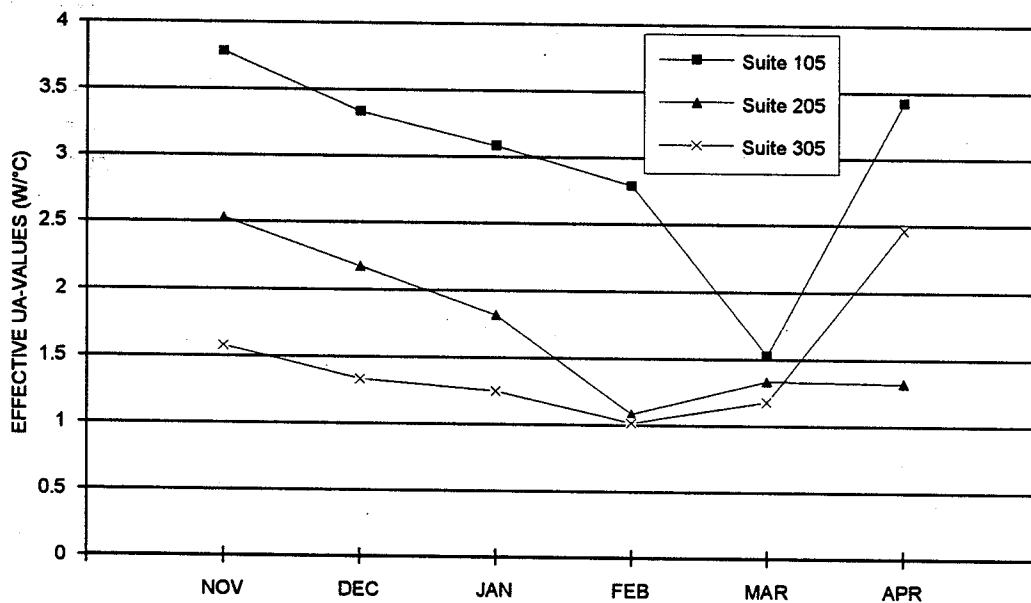
Figure 11: Effective UA Values of Individual Suites

With the NPL above the second floor level, the tendency would be for cold outside air to infiltrate into the first and second floor suites and for warm inside air to exfiltrate from the third floor suites. Under these conditions, the space heating requirements for the first and second floor suites would increase during the winter months compared to third floor suites. The greatest effect would occur on the first floor where infiltration would be the greatest. Air that exfiltrates from third floor suites is replaced by heated building air from the hallway and, therefore, does not affect the space heating requirement. Figure 11 shows the effective UA-values for Suites 105, 205, and 305, three suites of identical size, and indicates that this is exactly what is happening. It is known that the occupant of Suite 105 liked to keep a window open at night.

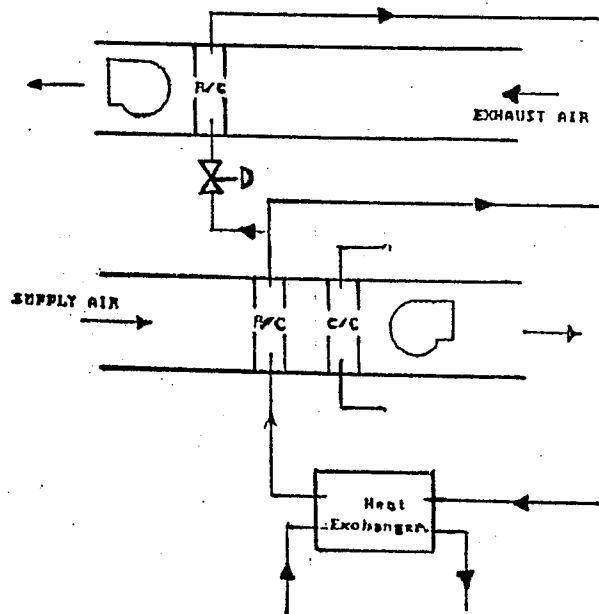
Figure 12: Original Heat Recovery System

The purpose of the heat exchanger was to supplement the heat supplied by the reclaim coil in order to provide the preheating necessary to raise the incoming outside air to the setpoint temperature of the supply air to the building. The use of one coil to serve as both the preheat and the heating coil was a relatively new concept and the effect on heat recovery efficiency was evaluated as part of this project. The system was designed for a constant supply air temperature of 15.5°C for both heating and cooling.

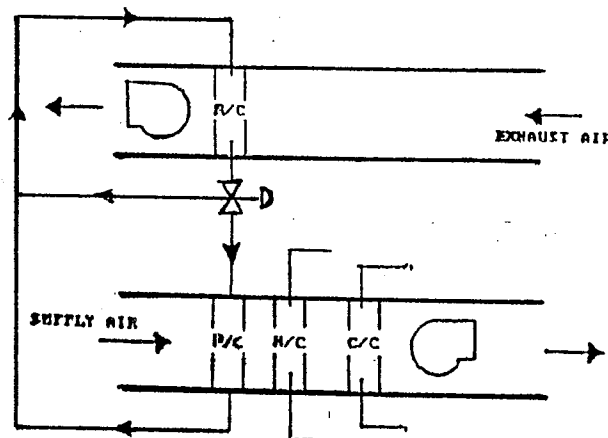
Figure 13: Heat Recovery System After Renovation

The purpose of the three-way mixing valve was to ensure that the heat recovery system operates within set limits. Heat recovery is controlled to prevent freezing of the reclaim coil by maintaining the temperature of the exhaust air flow leaving the reclaim coil above the low limit setpoint temperature of 2°C. Supply air preheating is controlled to prevent the temperature to the building from exceeding the high limit setpoint temperature of 20°C. The recovery loop circulation pump is de-energized when the outside temperature rises above the setpoint temperature.

- The tube-in-shell heat exchanger was removed from service.
- The manually operated bypass valve in the recovery loop was replaced with a three-way mixing valve controlled by the air temperature leaving the reclaim coil and the supply air temperature to the building.
- Filters were installed before the reclaim coil.
- Two new heating coils were installed in the ventilation supply air duct.
- The glycol concentration in the boiler loop was raised from 20% to 35% to provide added freeze protection for the heating coils.
- Adjustable speed drives were installed on the ventilation supply and exhaust fans, and on the space heating and boiler fluid loop pumps.

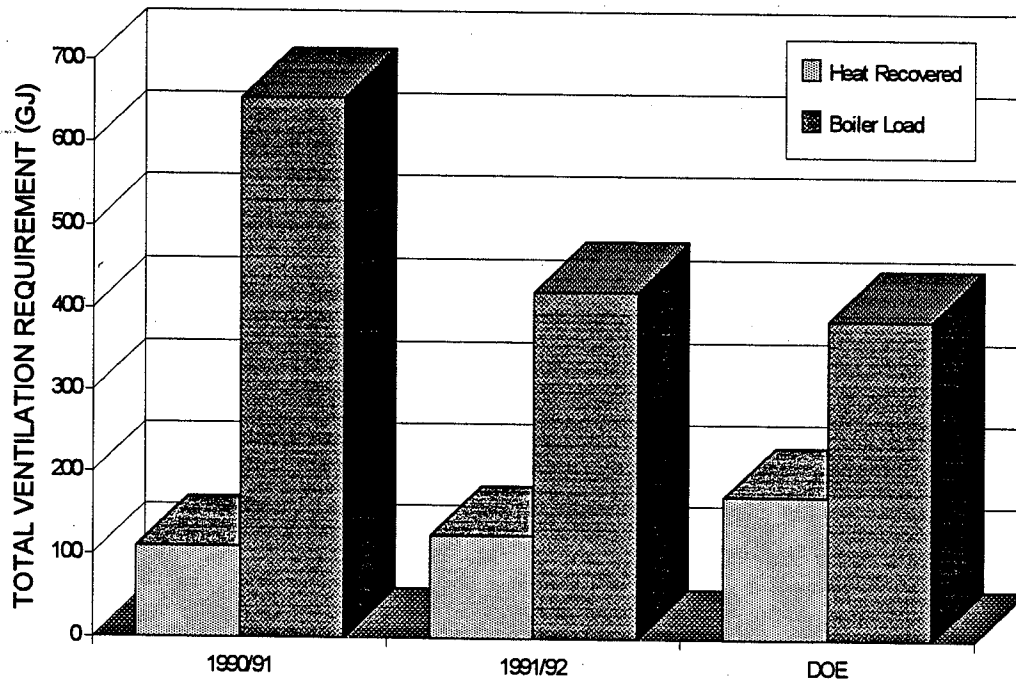
Figure 14: Changes in Amount of Heat Recovered

The sensible recovery efficiency of the system initially installed was low because of the large amount of heat supplied by the tube-in-shell heat exchanger. The 1990/91 project report [11], which details the analysis of the tube-in-shell heat exchanger, concluded that increasing the recovery efficiency would make the single largest contribution to improving building energy performance and recommended that major changes be made to the heat recovery system. This recommendation was supported by JMB and resulted in the *Heat Reclaim System Renovation* discussed in Section 3.4.3. Figure 14 shows the actual amount of heat recovered during the 1990/91 and 1991/92 heating seasons and DOE prediction of the heat which will be recovered for a TMY with the renovation completed.
